**ELIZABETH SCHOOL DISTRICT**

**FACILITIES MASTER PLAN**

**MAY 2018**

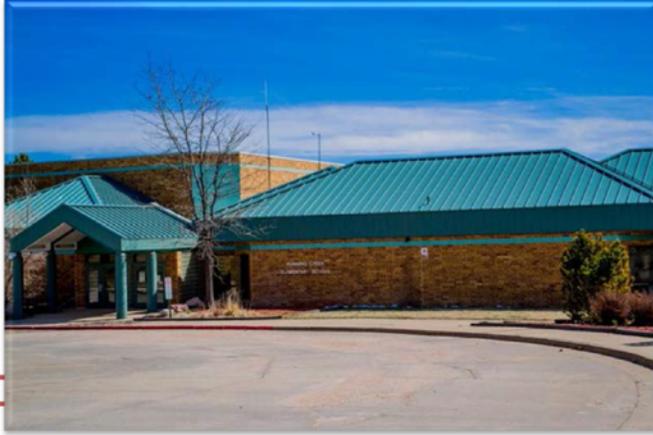
**Running Creek Elementary**

<b>Exterior Structure:</b> No observed issues.	<b>Interior Structure:</b> No apparent issues, but the interior walls and wall finishes have exceeded their life expectancy.	
	<b>Foundation:</b> No observed issues.	<b>HVAC/Plumbing:</b> Systems have exceeded their life-expectancy; however, they are functioning. Control system upgrades are needed.	
	<b>Roofing:</b> No observed issues. Replaced within last 10 years.	<b>ADA:</b> Restrooms are not ADA compliant; Door hardware and clearances are not ADA compliant.	
	<b>Parking/Traffic:</b> Repair and fill cracks in asphalt.	<b>Furnishings and Fixtures:</b> No observed issues.	
	<b>Site:</b> In many areas of concrete sidewalks and curb and gutter need to be replaced.	<b>Electrical:</b> System is functional, yet it is at the end of its life expectancy. Light fixtures have T-12 lamps and ballasts which should be upgraded to a more efficient type.	
	<b>Security:</b> Existing system is functional and operating as intended.	<b>Doors:</b> Functioning, but not ADA compliant.

<b>Windows:</b> Most windows are in good condition and have insulated	<b>Flooring:</b> No observed issues.

glass, but have exceeded their life expectancy.		
Priority Projects			
Concrete paving and curb and gutter repair/replacement. ADA upgrades. HVAC controls need to be upgraded.			
Additional Projects, if Funds Become Available			
HVAC, Plumbing, and Electrical system replacement.

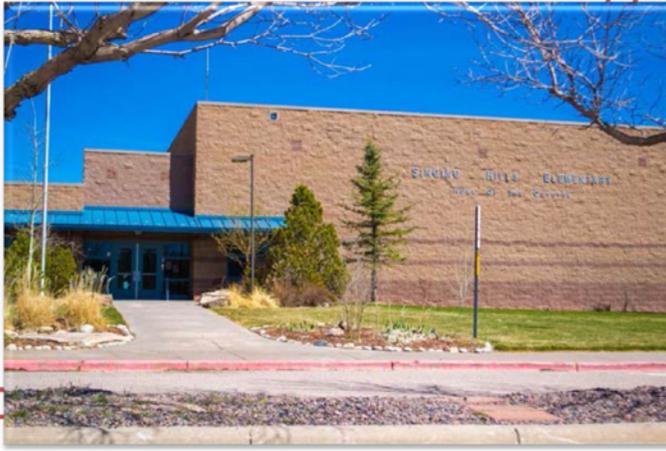
**Singing Hills Elementary**

System Rating Score:  Good Condition  Needs Improvement  Poor Condition			
	<b>Exterior Structure:</b> Good condition; General maintenance of caulking and sealers is needed.	<b>Interior Structure:</b> Appear in good shape and have been well maintained.	
	<b>Foundation:</b> The slab is settling in many locations.	<b>HVAC/Plumbing:</b> Systems have or soon will exceeded their life-expectancy; however, they are functioning. Control system upgrades are needed.	
	<b>Roofing:</b> All roofing has been replaced in last 2 years.	<b>ADA:</b> No observed issues.	
	<b>Parking/Traffic:</b> Repair and fill cracks in asphalt is needed.	<b>Furnishings and Fixtures:</b> No observed issues.	
	<b>Site:</b> In many areas of concrete sidewalks and curb and gutter need to be replaced.	<b>Electrical:</b> No observed issues.	
	<b>Security:</b> Existing system is functional and operating as intended.	<b>Doors:</b> No observed issues.

<b>Windows:</b> Many operable windows do not function.	<b>Flooring:</b> Some flooring has been replaced, but most of the flooring is past its life expectancy.	
<b>Priority Projects</b>

Repair the settling concrete slabs. Asphalt and concrete paving and curb and gutter repair/replacement. HVAC controls need to be upgraded.

Window replacement; HVAC, Plumbing, and Electrical system replacement.

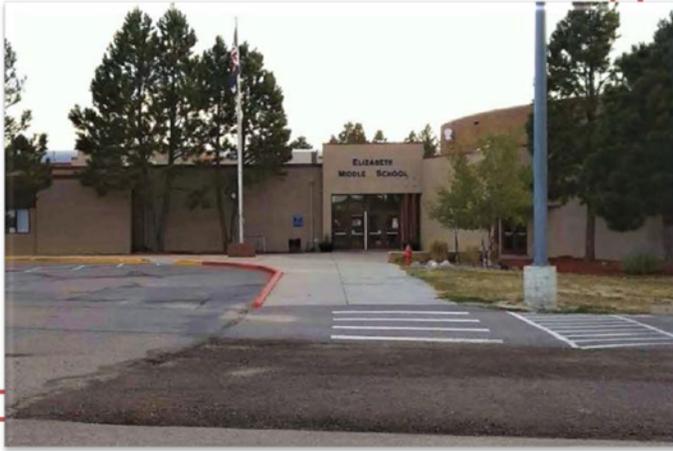
**Elizabeth Middle School**

<b>Windows:</b> Windows are single pane glazing, and water infiltration is evident; few windows in facility with minimal natural light.	<b>Flooring:</b> At the end of its useful life and requires replacement.

Site paving replacement; window replacement; EM Lighting system replacement are top priorities.

Replacement of HVAC system; Security upgrades; ADA upgrades, flooring

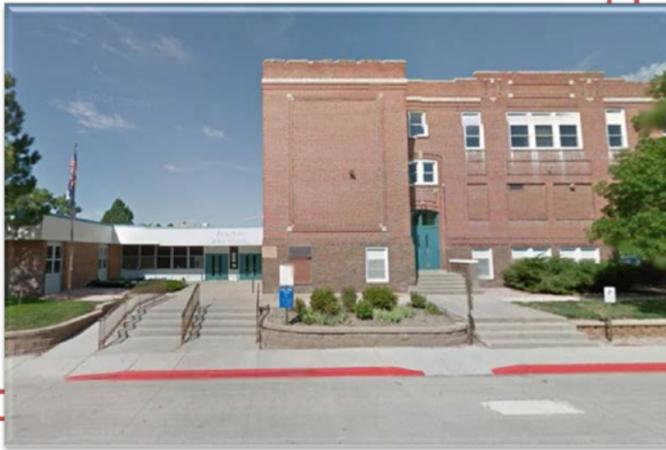
**Frontier High School**

System Rating Score: <span style="color: green;">●</span> Good Condition <span style="color: yellow;">●</span> Needs Improvement <span style="color: red;">●</span> Poor Condition			
● ● ●	<b>Exterior Structure:</b> Masonry Repairs/Tuckpointing is needed; Wood Fascia is deteriorating; Evidence of water infiltration.	<b>Interior Structure:</b> Past life expectancy; Many cracks in the existing plaster, Interior masonry walls appear sound.	● ● ●
● ● ●	<b>Foundation:</b> Appears to be in good condition for age; nearing end of life expectancy.	<b>HVAC/Plumbing:</b> Past Life expectancy; Majority of systems are original and have been fixed when broken with a "bandaid" approach. Complete system replacement is needed.	● ● ●
● ● ●	<b>Roofing:</b> Replaced in 2000; functioning well.	<b>ADA:</b> Restrooms and many spaces do not meet ADA requirements; Significant remodel work would be required to bring building up to ADA standards.	● ● ●

● ● ●	<b>Parking/Traffic:</b> At the end of its useful life, need to replace.	<b>Furnishings and Fixtures:</b> Most fixtures and furnishings are past life expectancy	● ● ●
● ● ●	<b>Site:</b> At the end of its useful life, sidewalks, stairs and paving are uneven and in poor condition.	<b>Electrical:</b> Past life expectancy; Entire system needs to be upgraded.	● ● ●
● ● ●	<b>Security:</b> Minimal security measure installed, lockset are failing.	<b>Doors:</b> Past life expectancy; hardware is not ADA compliant;	● ● ●

Failing doors and hardware have led to air and water infiltration and security issues.

<b>Windows:</b> At the end of their useful life; leaking air and moisture.	<b>Flooring:</b> Past life expectancy.

<b>Priority Projects</b>			
Masonry Repairs/Tuckpointing is needed; Wood Fascia is deteriorating; Replacement of windows and doors; Replacement of HVAC System; Site paving repairs.			
<b>Additional Projects, if Funds Become Available</b>			
ADA upgrades; site lighting; electrical system replacement.

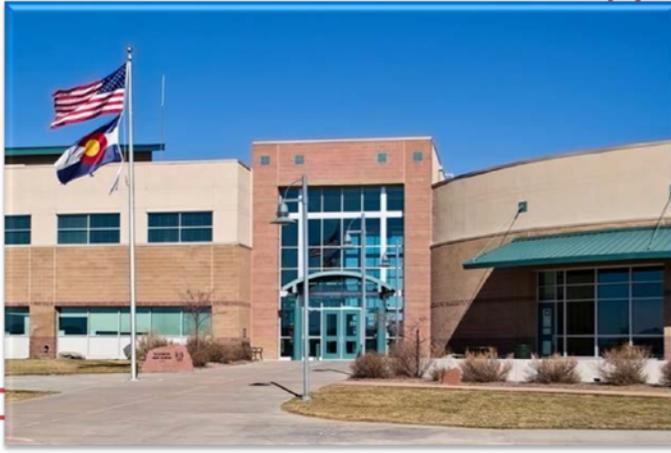
**Elizabeth High School**

<p><b>Windows:</b> While most windows are in good condition. Some have condensation build-up indicating the seals have been compromised.</p>	<p><b>Flooring:</b> No observed issues.</p>

Many areas of site paving are deteriorating. Review snow/ice removal practices. Many areas are in need of replacement.

Exterior masonry and storefront caulking. Apply sealers to the exterior CMU. Stair tread bull nose replacement. These general building maintenance items will greatly help extend the life of the building. HVAC controls need to be upgraded.
